Copper Tubing Evaluation in A Natural Gas Environment

**Project No.#: TS00-M036
Final Report, July 3, 2002**

Work performed jointly for
Copper Development Association Inc. and
Southern California Gas Company

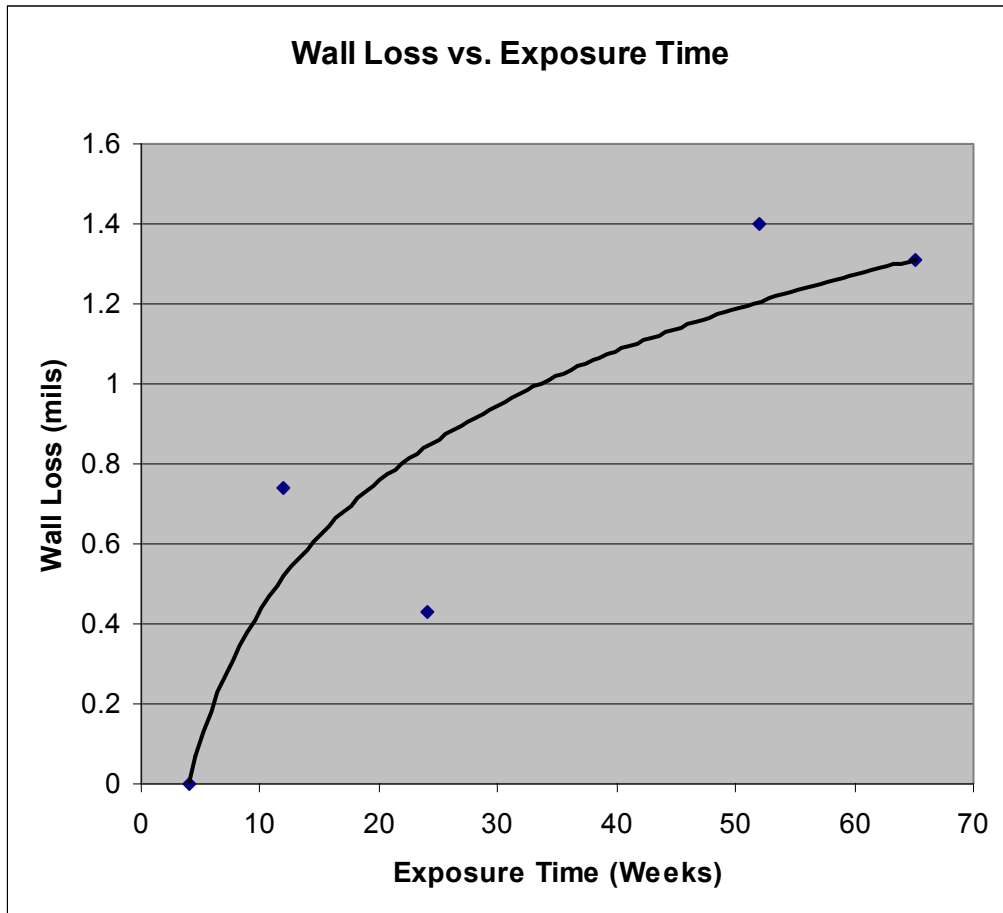
Figure A. Copper Tube Wall Loss vs. Exposure Time

The acceptable “useful service life” of the copper tubing is defined in **Section 2.5** as having a remaining wall thickness of greater than 80% of the nominal at the end of 20 years in service. For the standard ½-in. outside diameter, 0.05-in. thick wall copper tubing samples, the allowable wall loss is 10 mils. This is based on the assumption that corrosion wear was uniform throughout the samples. As such, the wall loss is calculated on the basis of tubing sample weight measurements before and after the specified exposure period (**Table 3**). Any localized corrosion resulting in pitting other than general surface wear would have to be assessed as to the resulting penetration into the tube wall. The following graph (**Figure A**) shows a plot of the amount of wall loss versus exposure time. The projected wall loss at 20 years of service life for bare copper tubing is well below the 10 mils limit. Based on a uniform wall loss assumption, the data suggest that bare copper tubing will maintain structural integrity for the duration of its “service life.”

However, examination of the interior surfaces of the bare copper tubing revealed that corrosion wall losses were not uniform. Several sites of localized pitting extending deeper into the tube wall were visible. The presence of these pits and their resultant effect on wall loss had to be accounted for to ensure that these localized areas of pitting would not jeopardize the tubing wall and result in wall thickness less than that specified in the performance criteria. Examination of these pitting sites indicated that while the pits were deeper than the surrounding general surface corrosion, they were still too shallow to be measured with available instruments. Thus they were not significant enough to exhibit a measurable difference in the expected service life and are not a cause for failure of the performance criteria. Also, the average wall loss after 20 years of projected usage is so small that the preferential corrosion sites would have had to exhibit an increased corrosion rate approximately 35 times higher than the average rate to actually develop a pinhole in the accepted service life. If these sites had been corroding at this extreme rate, then the visible pits would have exhibited a measurably greater depth, which is not corroborated by the observed results.

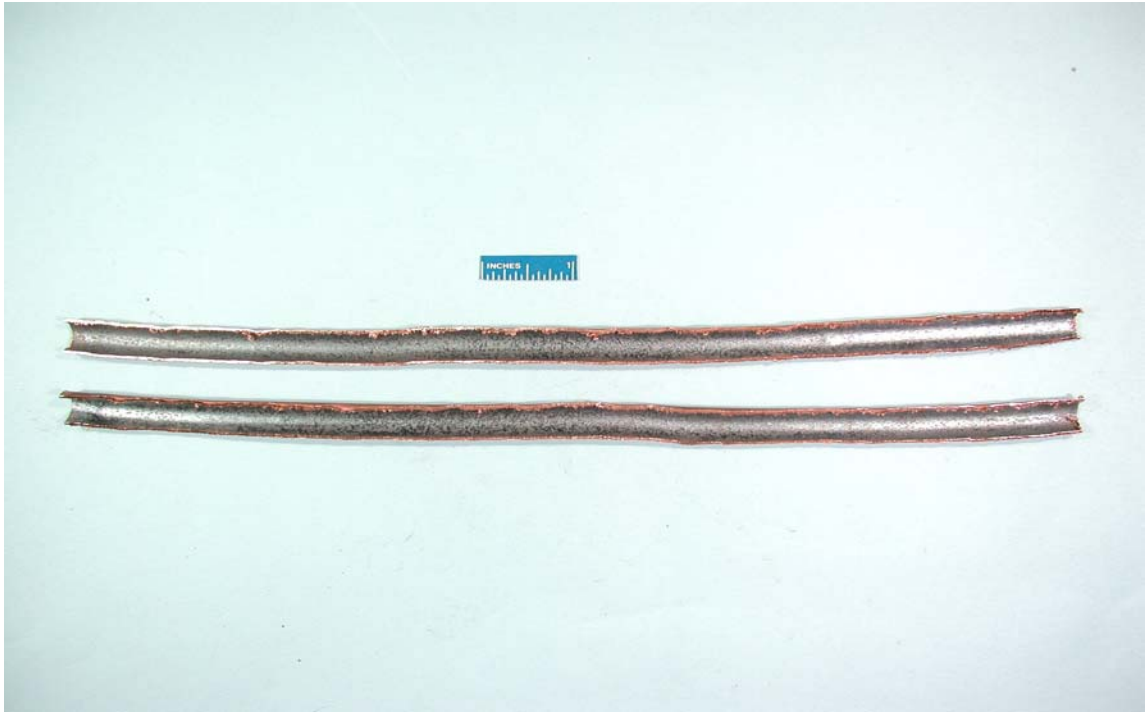
The bare copper tubing was split in half to reveal the extent of internal corrosion as a result of natural gas flow during the 52-week exposure period. The interior surface of the sample exhibited a coating of black corrosion products distributed across the entire interior surface of the sample (**Figures 2 and 3**). The copper tube wall beneath this corrosion product layer exhibited some roughening of the surface as a result of shallow, indistinct surface pitting. This general surface pitting was not measurable by the available instruments. No distinct, deep/active corrosion pitting sites indicative of aggressive localized pitting corrosion were identifiable on the interior surface of the tube.

Figure 2. Bare copper sample split in half after 52-weeks' exposure.

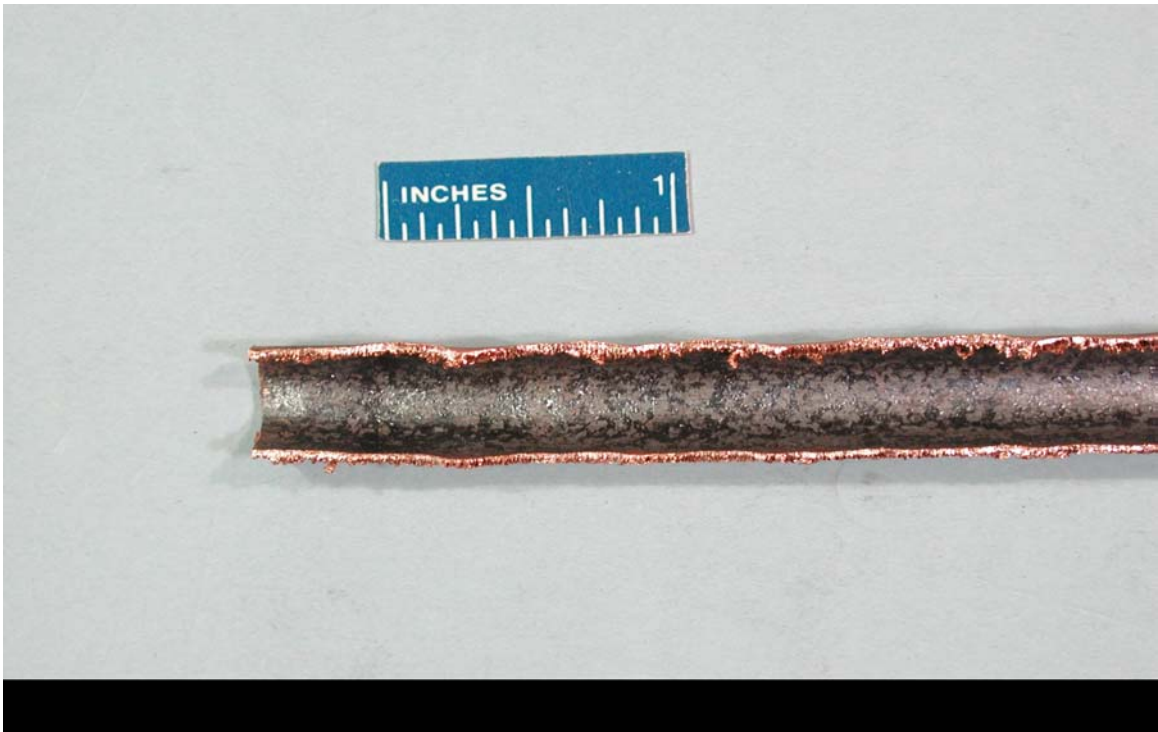
Figure 3. Close-up view of corrosion deposit on the inside of the bare copper sample after 52- weeks' exposure.

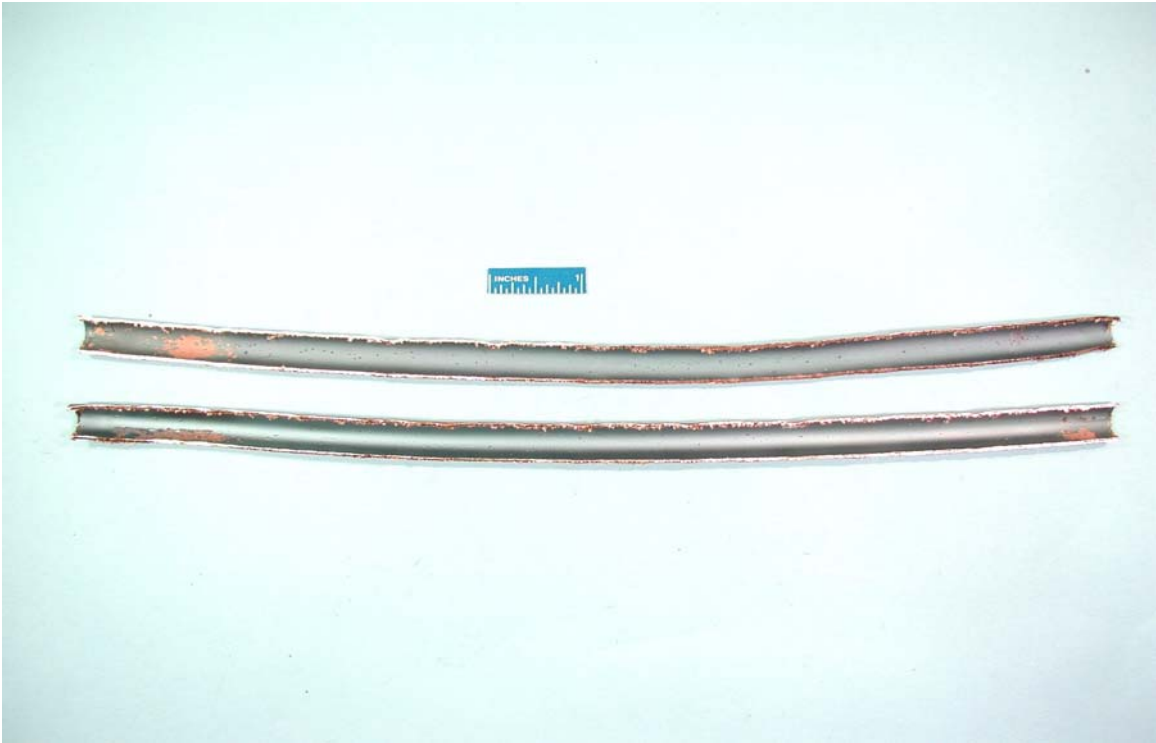
The tin-lined copper tubing sample was visually inspected after being split lengthwise. The tin coating had discolored to charcoal black color with isolated pits. There were two areas where the protective tin coating exfoliated exposing the bare copper surface material underneath (**Figures 4 and 5**).

Figure 4. Tin-lined copper sample split in half after 52-weeks' exposure.

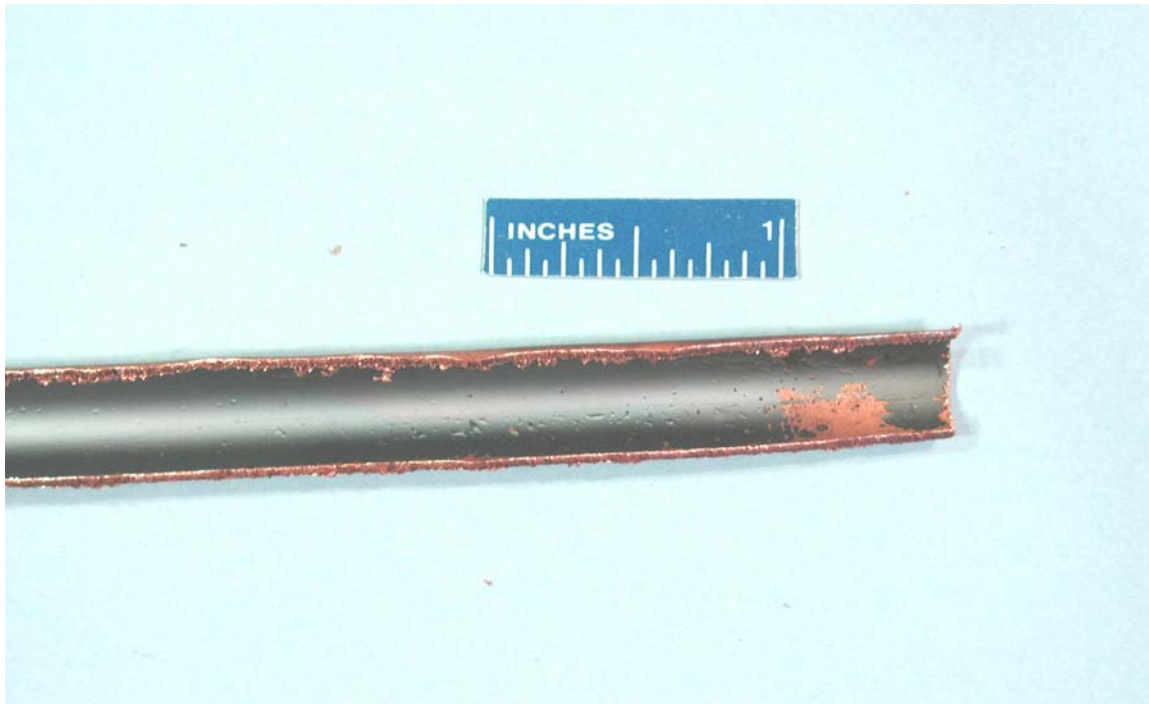
Figure 5. Close-up view of the isolated pits and an area of failed tin coating.

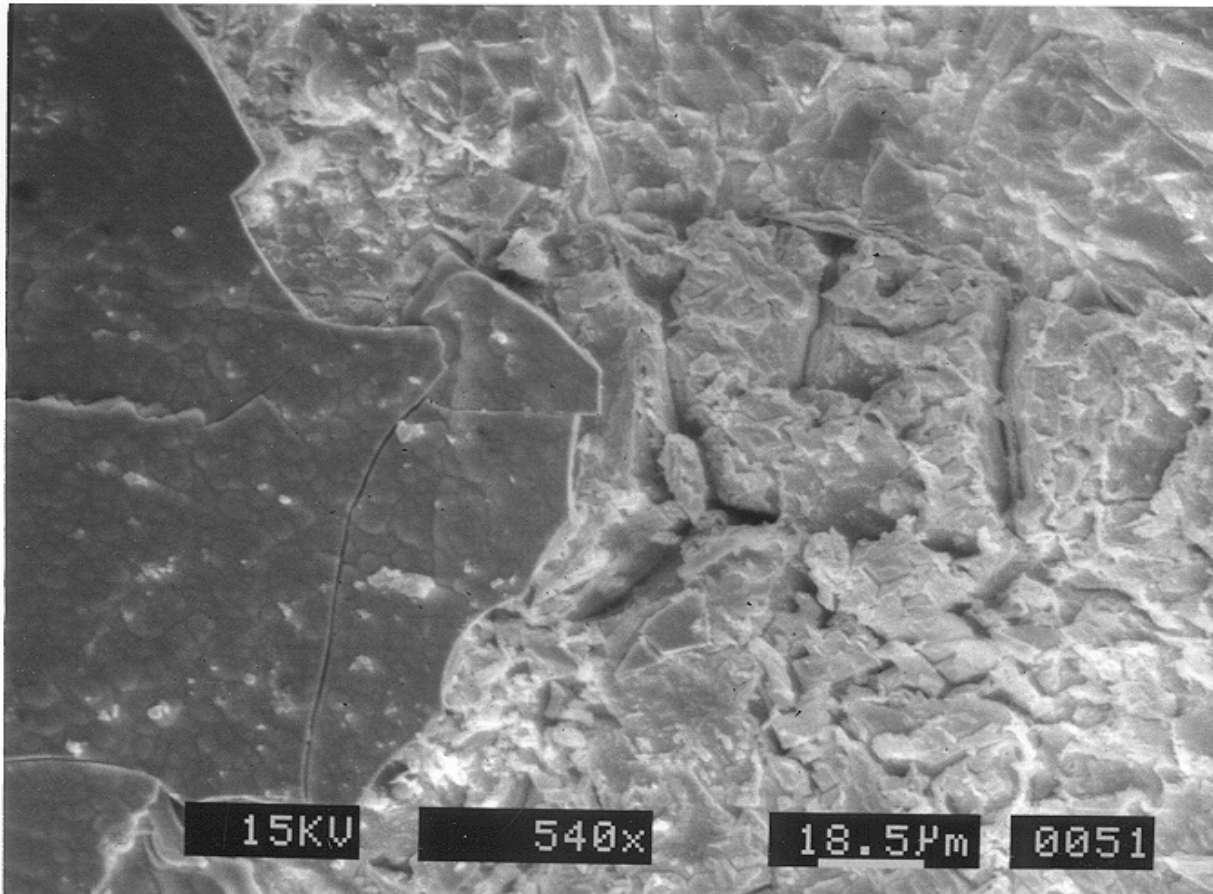
Elemental mapping of the deposit was determined by using a scanning electron microscope with energy dispersive x-ray spectroscopy (SEM/EDX). The analysis of corrosion deposits revealed that it contained predominantly copper (Cu) and sulfur (S), which most likely were in the form of copper sulfide. A spectrum showing the results is attached in **Appendix A**. Close-up views of the surface morphology revealed that corrosion products formed on the bare copper sample was friable with cracks that could easily break away from the tubing wall (**Figure 6**). **Figures 7 and 8** showed where the

**Figure 6. Close-up view of the surface morphology on the bare copper tubing.
Note the corrosion products on the left were brittle with fractured lines.**

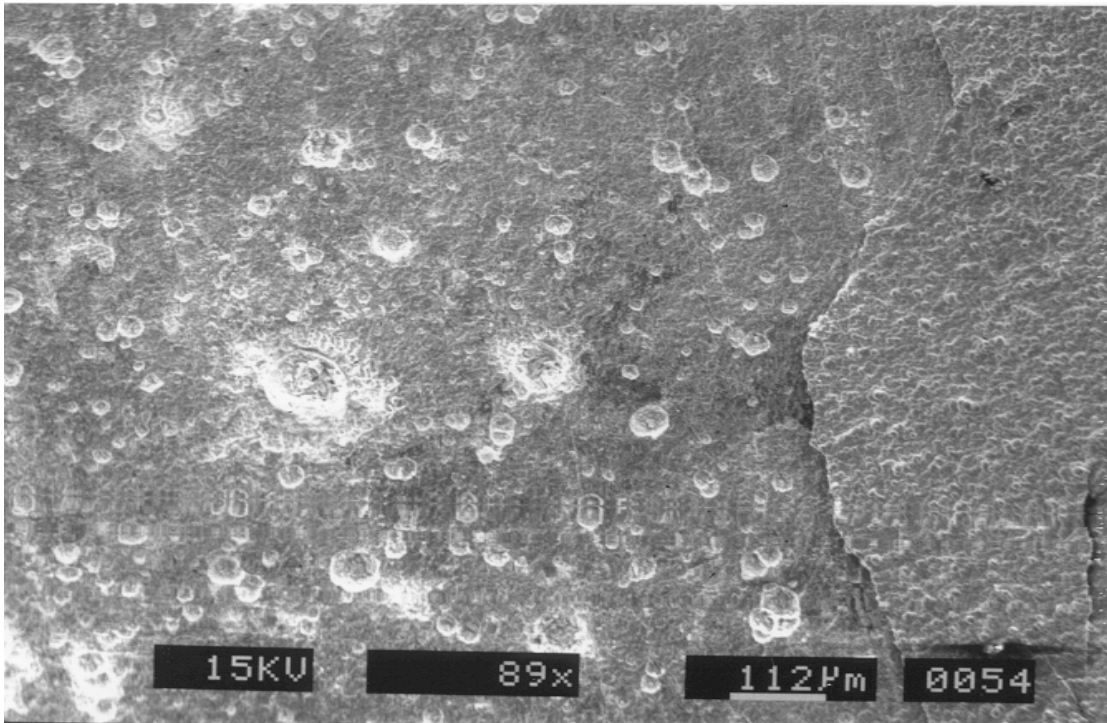
protective tin coating exfoliated and allowed formation of similar corrosion byproduct deposits in those areas and on the bare copper tubing.

Figure 7. Surface morphology of the tin-lined copper tubing.

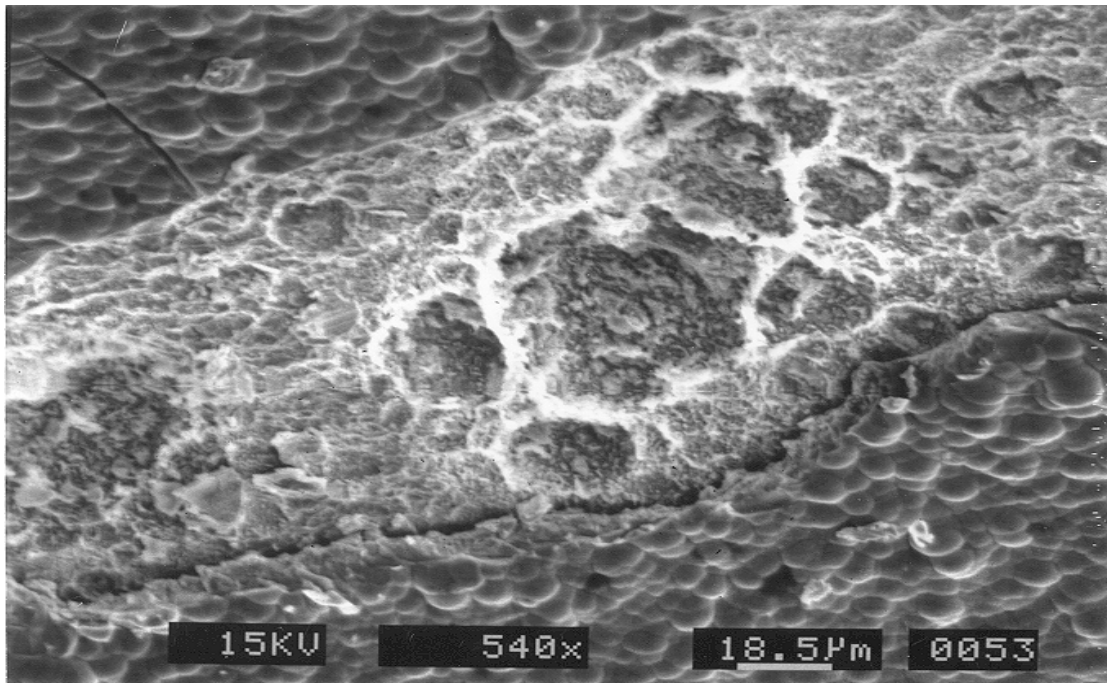
Figure 8. Close-up of an area where tin coating failed at the surface exposing copper tubing to a flowing gas stream.
