# Water- and Soil-Side Corrosion of Copper Water Service Lines

Arthur Cohen

Andrew J. Brock

*A study was conducted of the soil- and water-side corrosion of underground copper water service lines from various locations in Billings, Montana. The tubes had been in service from 10 to 70 years, and the extent of corrosion was directly related to the tubes' location in the city. The study showed that copper has excellent resistance to the indigenous soils and water.*

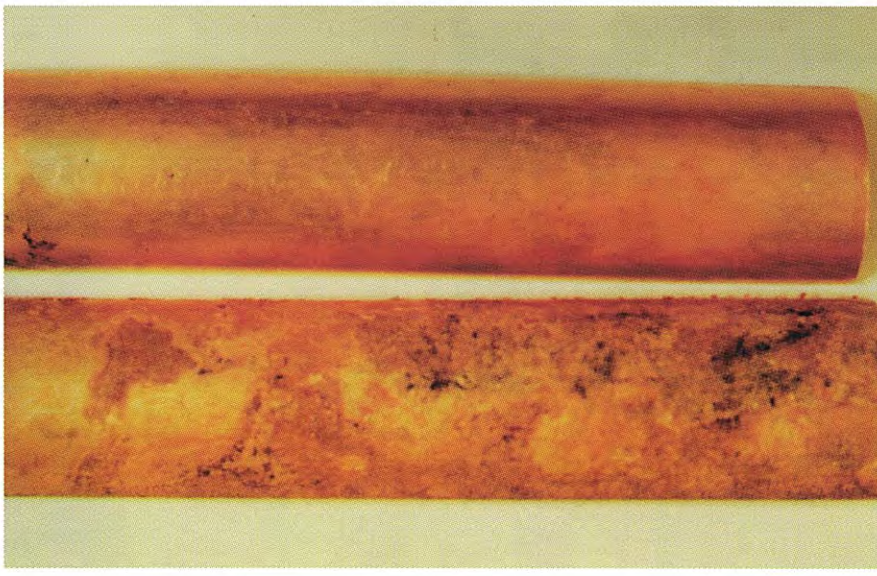
FIGURE 1

Typical outside surface condition of as-excavated tubes after up to 70 years' soil-side exposure.

A total of 110 samples of annealed-temper seamless copper water tube produced to the types K and L wall-thickness schedules of ASTM B 88<sup>5</sup> from eight locations were visually examined at magnifications up to 40x. Figure 1 shows the surface condition of as-excavated tubes after

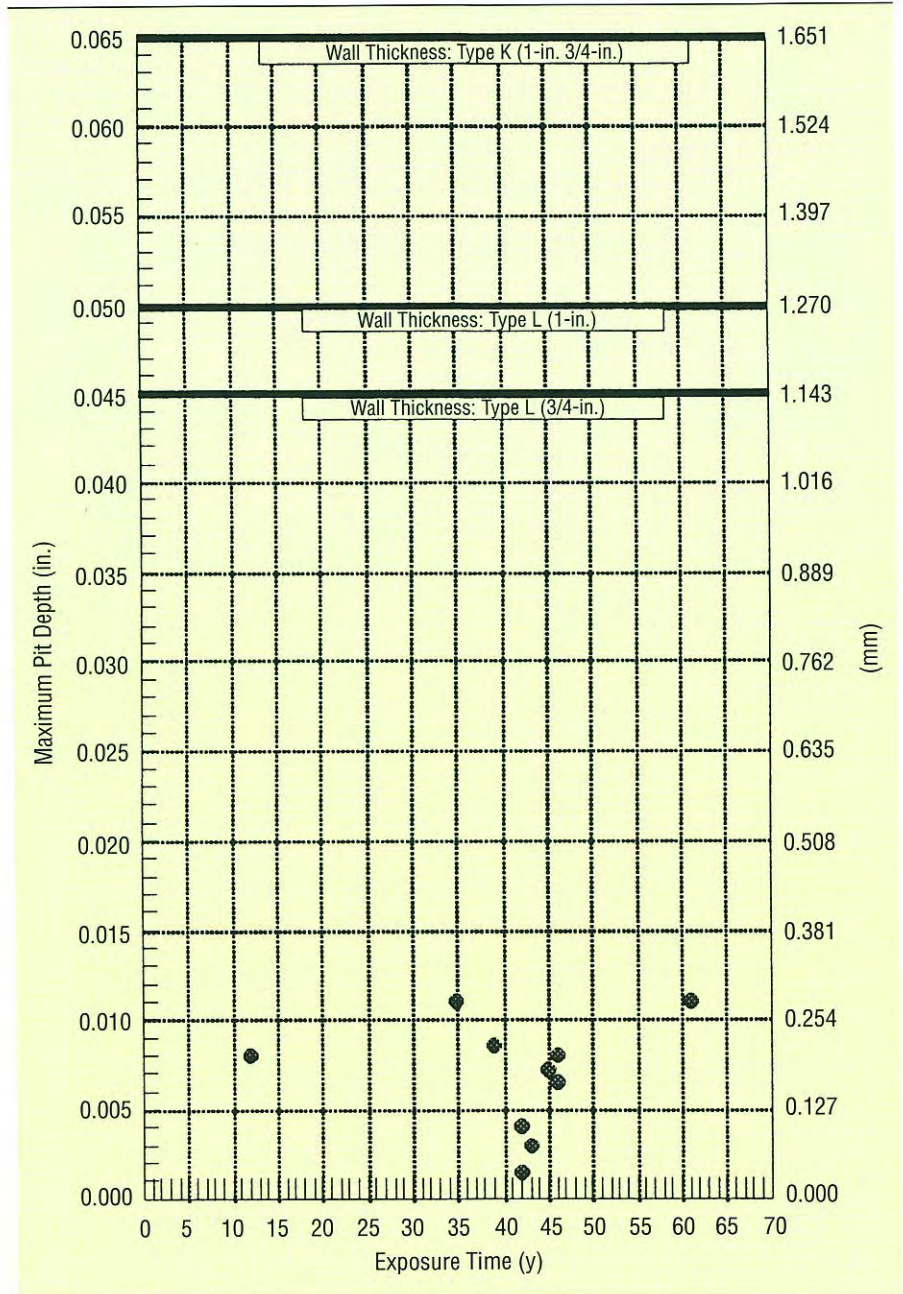
Detailed descriptions of the tubes examined in their as-excavated and cleaned conditions, together with their maximum and average depths of pitting and surface roughness, are described in Table 2. The maximum depths of pitting as a function of exposure time are plotted in Figure 2. The graph shows that even with a maximum soil-side pit depth of 0.011 in. (0.28 mm) after 35 years' exposure, the service life of the underground water lines at these locations would extend into the hundreds of years.

**FIGURE 2** Maximum pit depth as a function of exposure time to the various soil conditions (points). Dark horizontal lines represent the original pipe wall thicknesses.

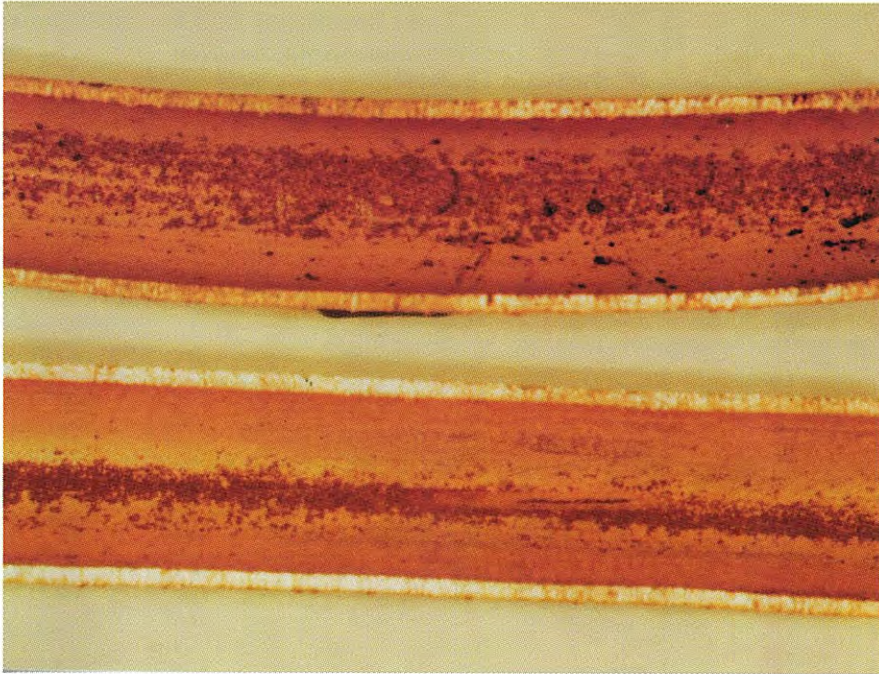
**FIGURE 3**

Typical inside surface of as-cleaned tubes from Harvard Avenue after up to 48 years' service (top: installed 1949; bottom: installed 1946).

The cleaned surfaces of some tubes exhibited more severe corrosion than others (Figure 3). This attack probably was caused by the

deposit and the differential aeration cells produced by the deposits.

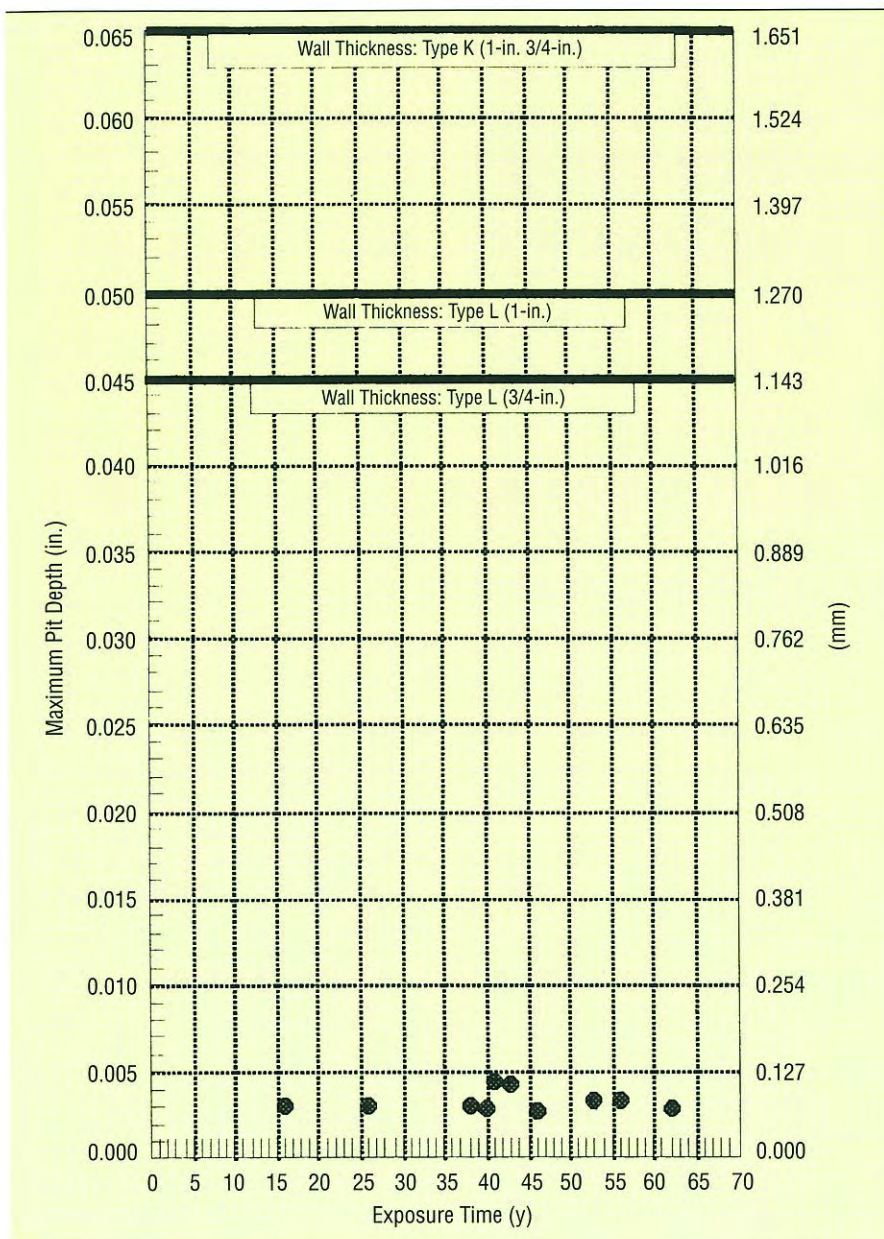
FIGURE 4

Irregular penetration of the tube wall also occurred. Corrosion products inside the pits were predominantly cuprous oxide. The maximum depth of the pits is less than 5% of the wall thickness after 29 years' service. As demonstrated by the data plotted in Figure 4, anticipated tube service lives would be many times those of the exposures represented. The figure clearly shows that, even with a maximum water-side pit depth of 0.0044 in. (0.11 mm) after 41 years' exposure, service lives of underground water lines would extend to hundreds of years.

Maximum pit depth as a function of exposure time to the municipal water supply (points). Dark horizontal lines represent the original pipe wall thicknesses.
